SINGLE FAMILY HOME

H&H Home Inspections

Inspection Questions

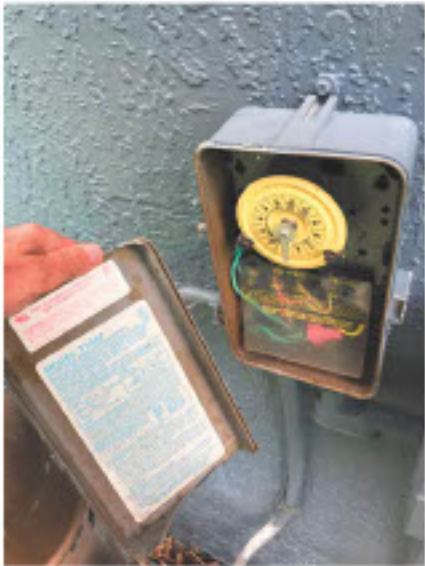
Observed timer box cover broken. Recommend replacement to prevent water penetration from damaging controls

Location: Pool equipment

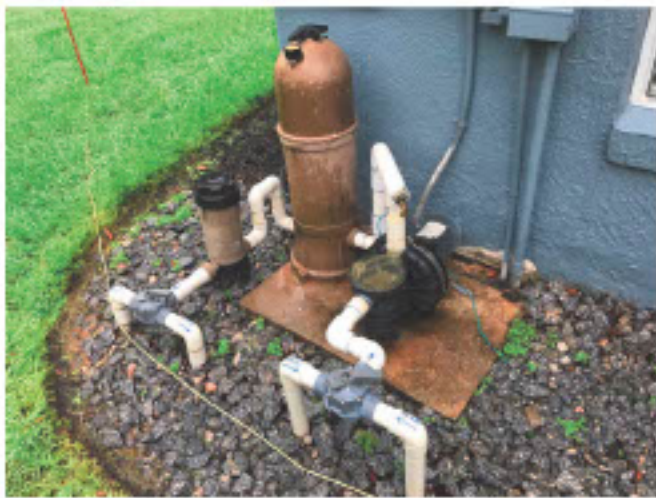
Note pool equipment was visually inspected and no damage or leaking at time of inspection. Recommend having qualified pool contractor do exhaustive inspection of all components for condition and functionality

Location: Pool equipment

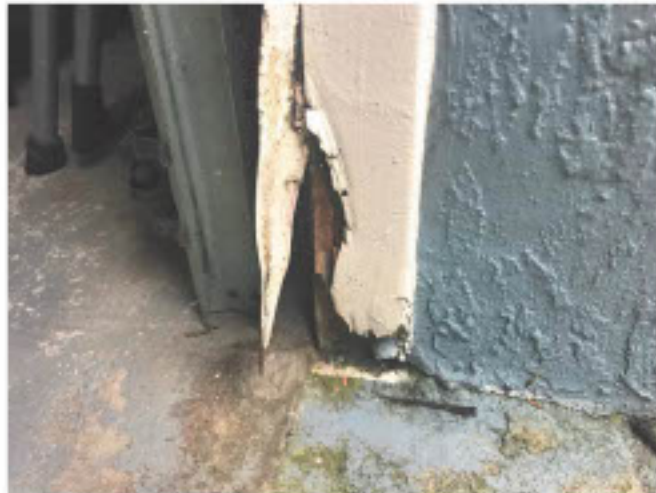
Observed water damage and wood rot on lower section of door framing. Recommend replacement of damage materials and replacement with composite materials to eliminate water damage

Location: Garage

door frame

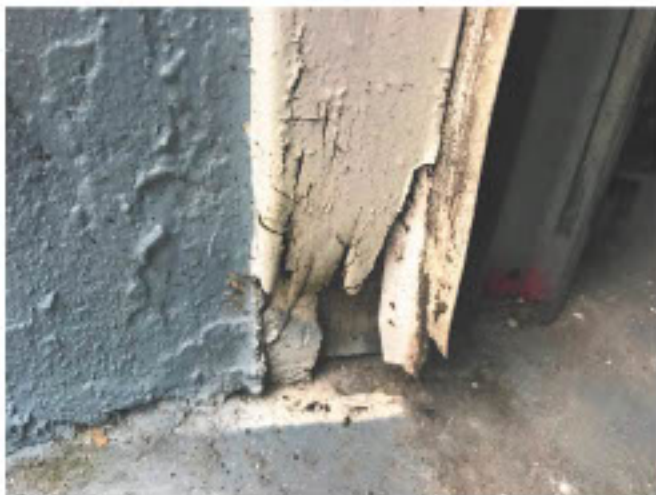
Observed water damage and wood rot on lower section of door framing. Recommend replacement of damage materials and replacement with composite materials to eliminate water damage

Location: Garage

door frame

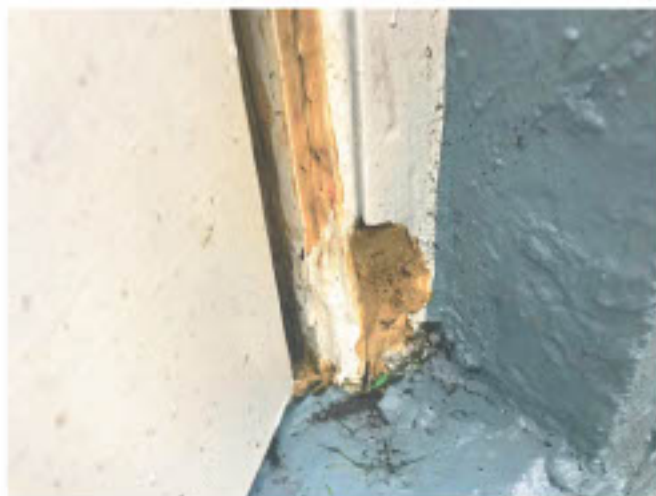
Observed water damaged lower section of interior door jamb. Recommend replacement of damage materials with composite materials to eliminate future water damage issues

Location: right

door frame

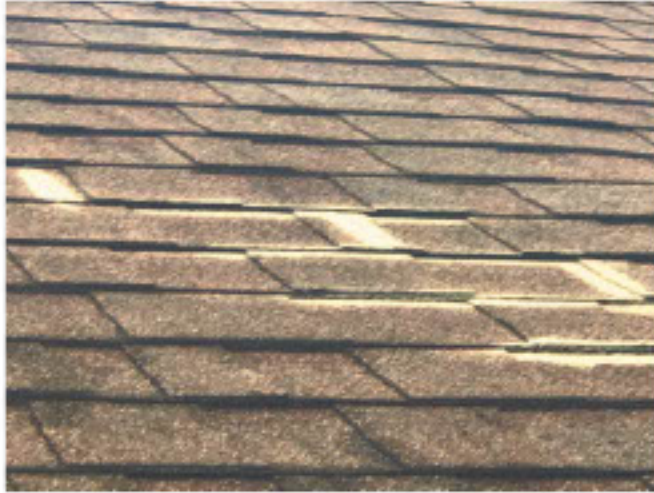
Observed previous shingles repairs over garage. No visible water penetration noted within attic space. Inquire with seller for further details regarding repairs

Location: Right side

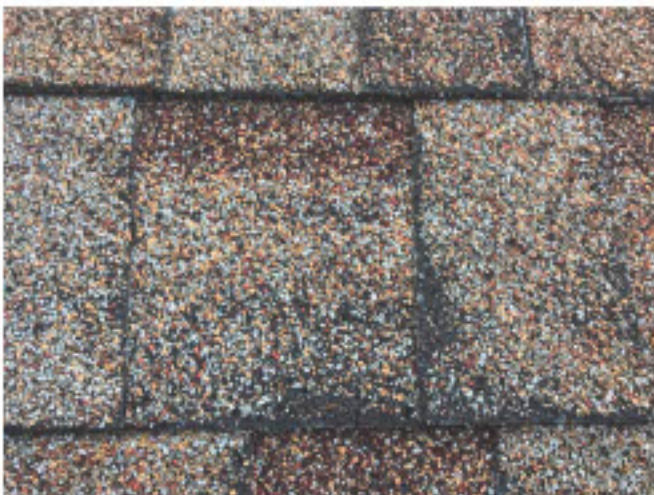
Observed shingles have granular loss and drying in various locations. No broken or missing shingles at time inspection. Understand shingles near end of functional design life and unable predict future functionality. Recommend budget for full replacement sooner than later

Location: various locations

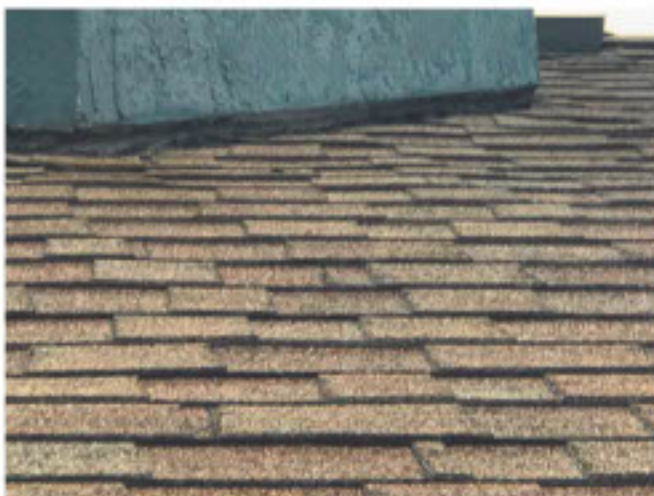
Observed soft depressions around chimney. Indicating potential damage sheathing. Remember upon replacement of shingles sections of sheathing may require replacement

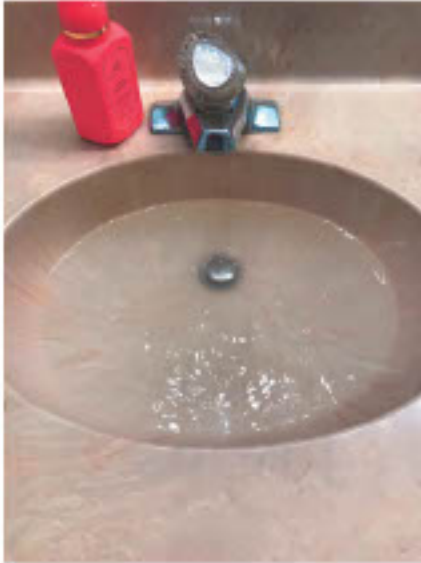
Observed left sink slow draining requires cleaning trap for normal drainage

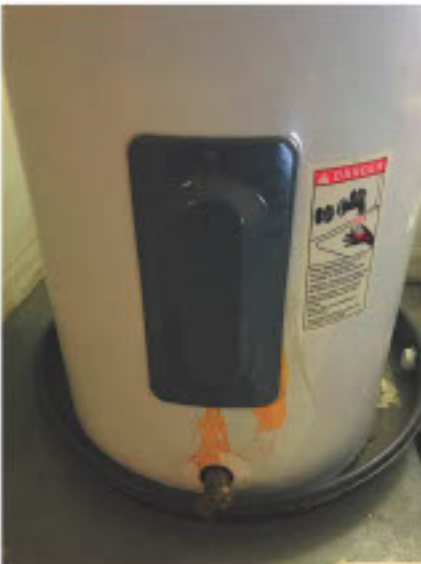
Observed rusting and corrosion on metal jacket. Unit tested functional during inspection This is indication unit nearing end of functional design life and due to age unable to predict future functionality. Recommend budget for replacement by license plumber

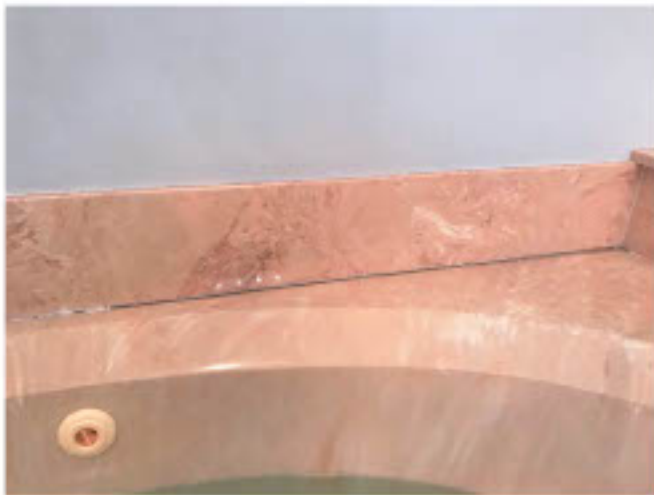
Observed damaged or missing caulking around tub. To prevent water penetration behind walls be sure to seal all intersections with bathroom silicone caulking

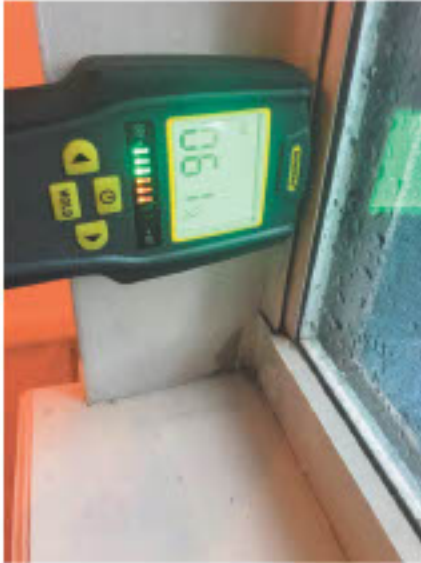
Observed moisture meter detected moderate level of moisture penetration typically occurs from exterior water penetration around window framing. Recommend caulk sealing exterior window framing

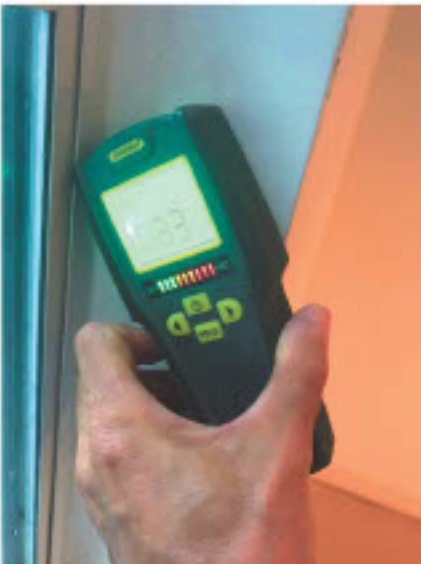
Observed moisture meter detected moderate level of moisture penetration typically occurs from exterior water penetration around window framing. Recommend caulk sealing exterior window framing

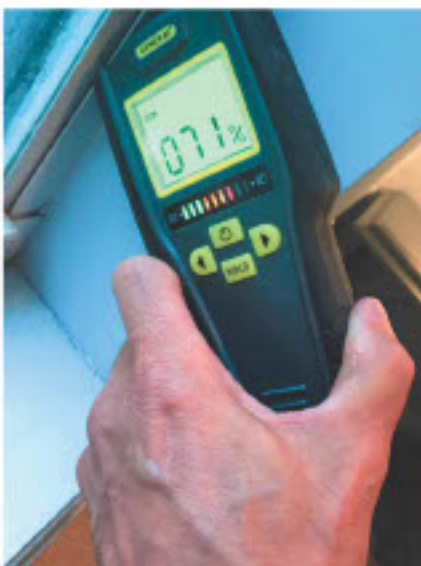
Observed moisture meter detected moderate level of moisture penetration typically occurs from exterior water penetration around window framing. Recommend caulk sealing exterior window framing

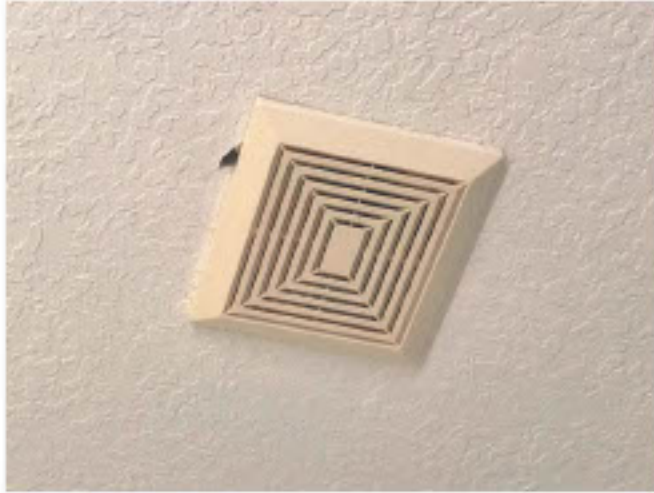
Observed small hole around exhaust fan cover. recommend repairs for full cosmetic finish

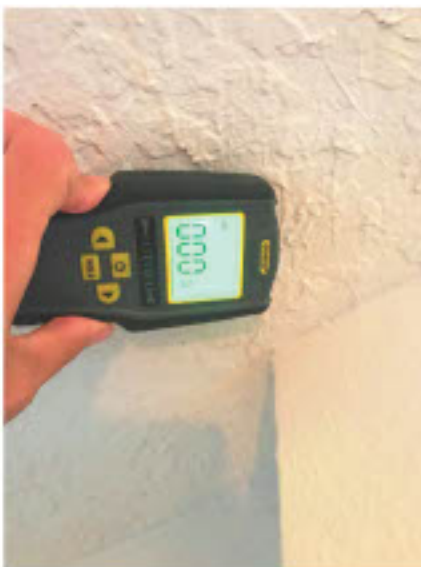
Observed moisture meter detected dry conditions within drywall indicating previous water stains

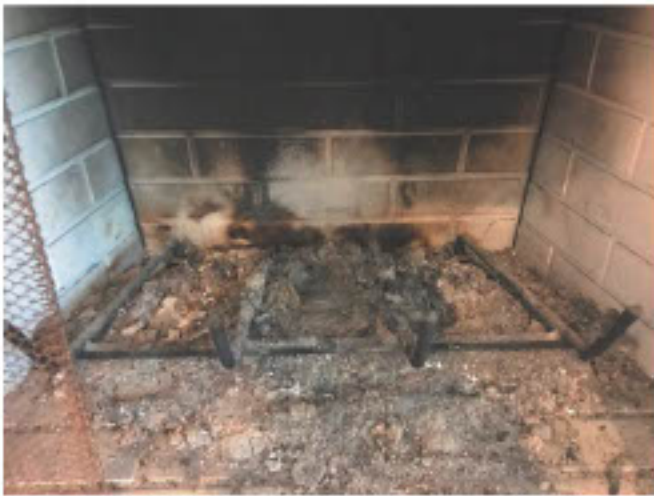
IMMEDIATE EVALUATION RECOMMENDED

Observed inner hearth and flue are dirty this is potential fire safety issue. Recommend having entire flue length professionally cleaned, all related components, inspected, tested and certified safe for use by qualified chimney contractor

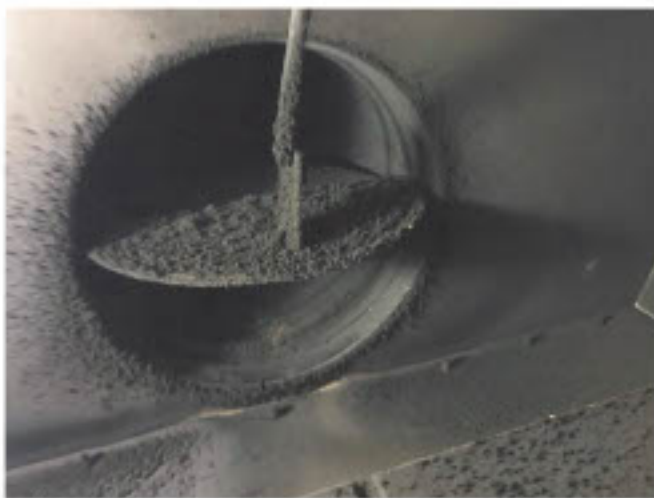
IMMEDIATE EVALUATION RECOMMENDED

Observed damper tested functional. Unit is dirty and has corrosion. Recommend prior to use having fireplace components inspected, cleaned certified safe for use by qualified chimney contractor

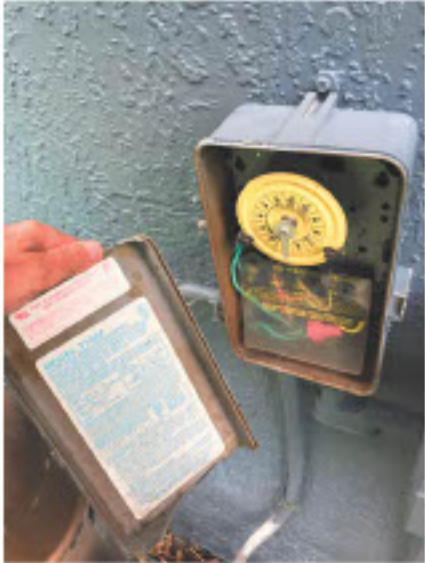
Observed timer box cover broken. Recommend replacement to prevent water penetration from damaging controls

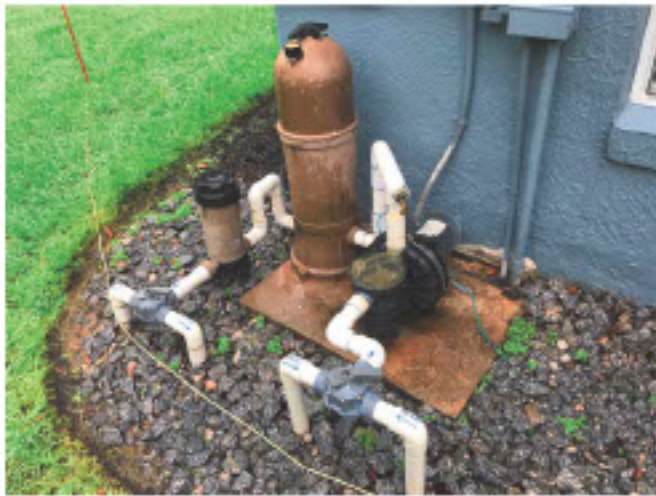
Note pool equipment was visually inspected and no damage or leaking at time of inspection. Recommend having qualified pool contractor do exhaustive inspection of all components for condition and functionality

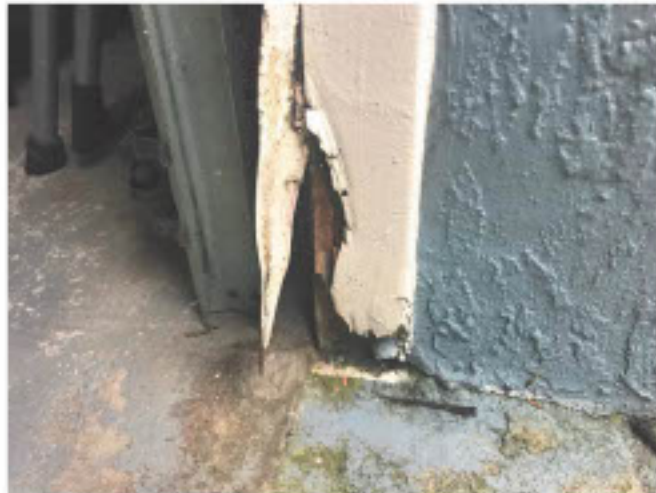
Observed water damage and wood rot on lower section of door framing. Recommend replacement of damage materials and replacement with composite materials to eliminate water damage

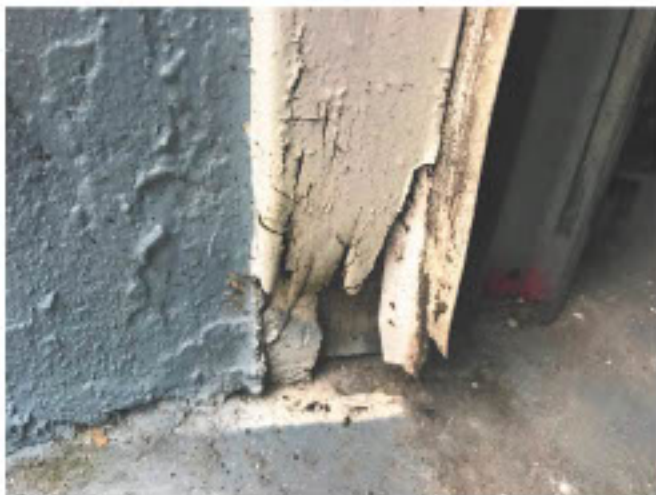
Observed water damage and wood rot on lower section of door framing. Recommend replacement of damage materials and replacement with composite materials to eliminate water damage

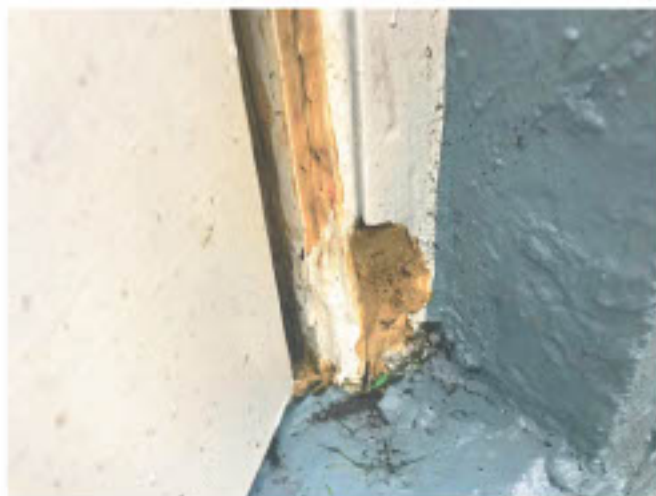
Observed water damaged lower section of interior door jamb. Recommend replacement of damage materials with composite materials to eliminate future water damage issues

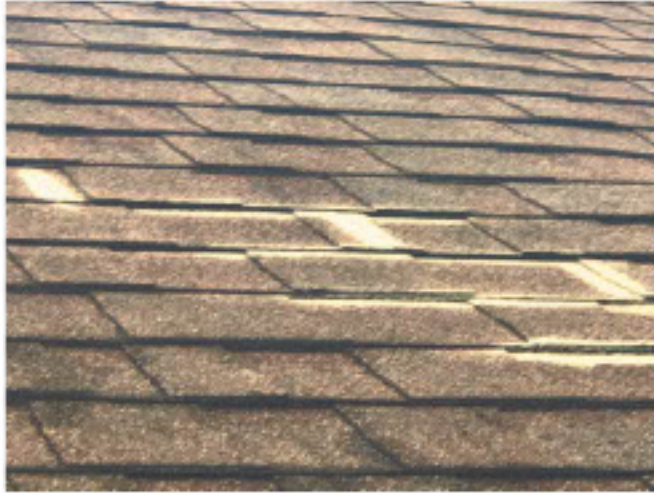
Observed previous shingles repairs over garage. No visible water penetration noted within attic space. Inquire with seller for further details regarding repairs

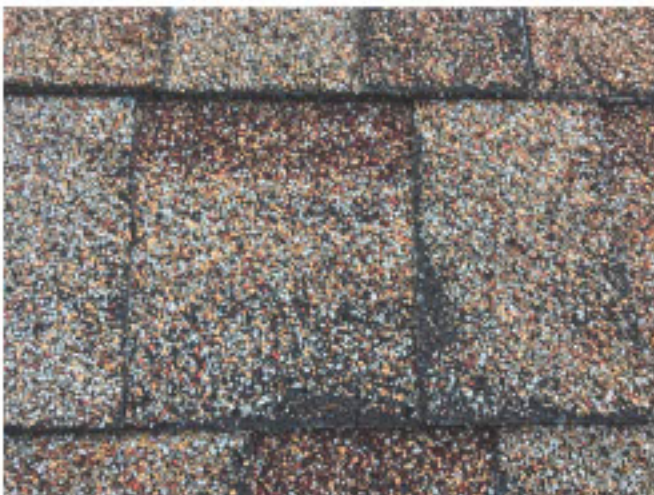
Observed shingles have granular loss and drying in various locations. No broken or missing shingles at time inspection. Understand shingles near end of functional design life and unable predict future functionality. Recommend budget for full replacement sooner than later

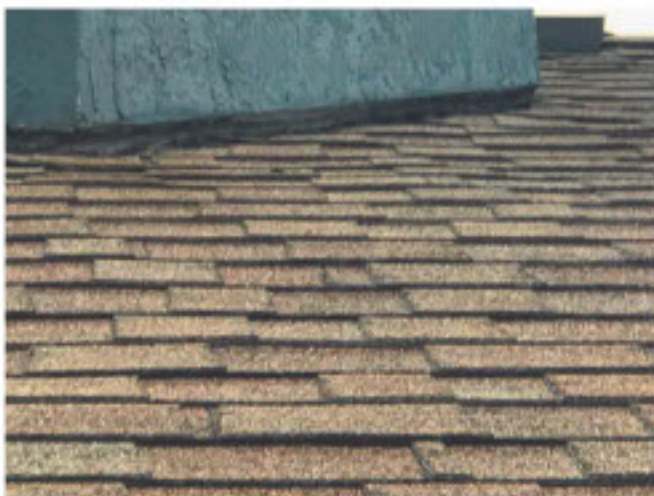
Observed soft depressions around chimney. Indicating potential damage sheathing. Remember upon replacement of shingles sections of sheathing may require replacement

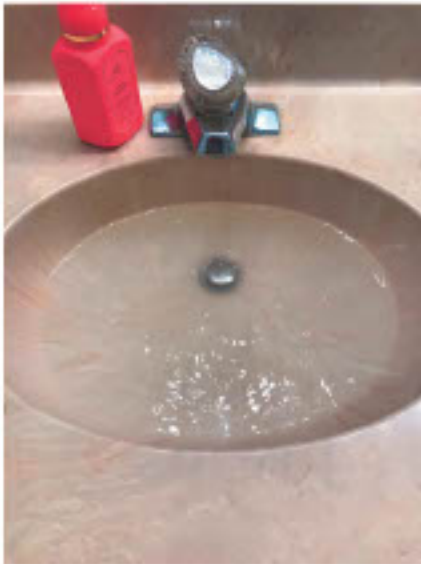
Observed left sink slow draining requires cleaning trap for normal drainage

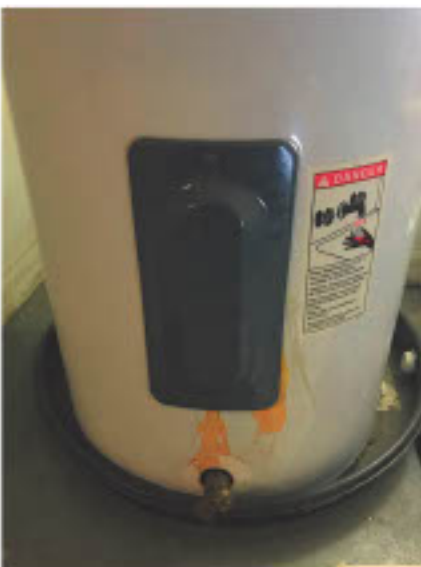
Observed rusting and corrosion on metal jacket. Unit tested functional during inspection This is indication unit nearing end of functional design life and due to age unable to predict future functionality. Recommend budget for replacement by license plumber

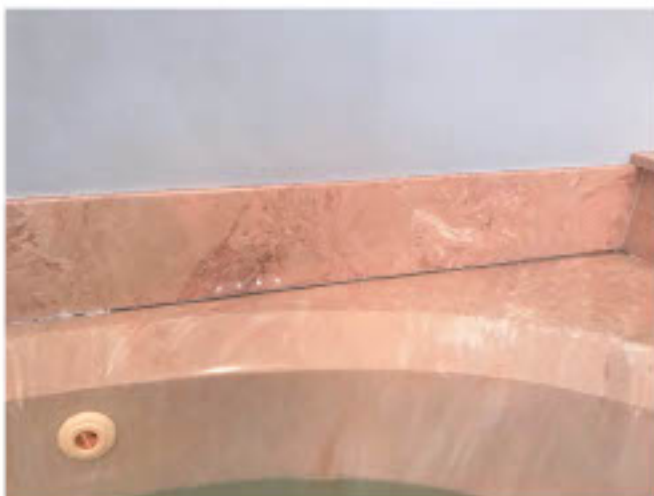
Observed damaged or missing caulking around tub. To prevent water penetration behind walls be sure to seal all intersections with bathroom silicone caulking

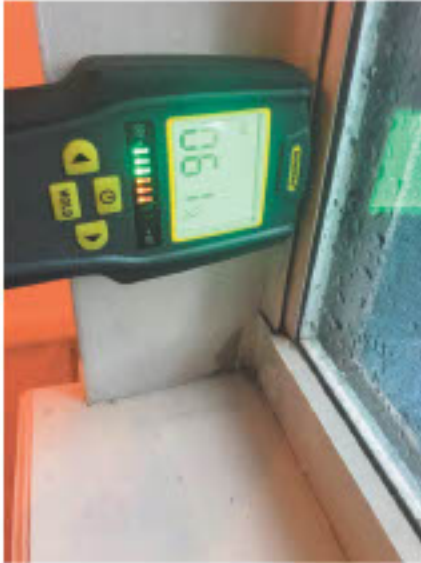
Observed moisture meter detected moderate level of moisture penetration typically occurs from exterior water penetration around window framing. Recommend caulk sealing exterior window framing

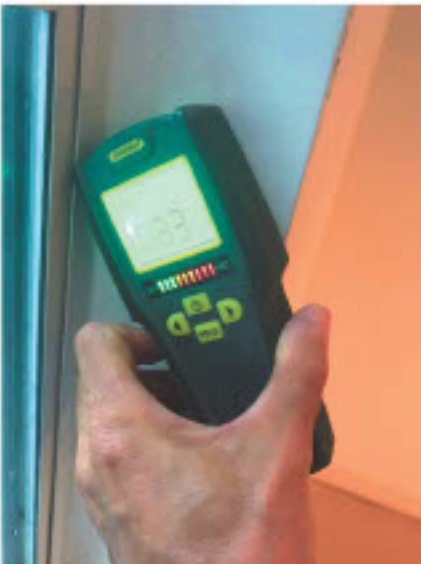
Observed moisture meter detected moderate level of moisture penetration typically occurs from exterior water penetration around window framing. Recommend caulk sealing exterior window framing

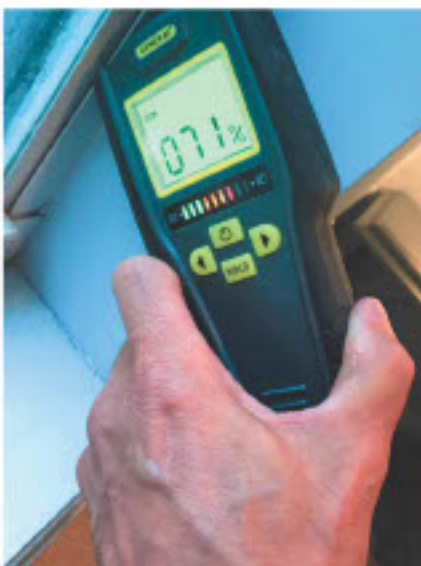
Observed moisture meter detected moderate level of moisture penetration typically occurs from exterior water penetration around window framing. Recommend caulk sealing exterior window framing

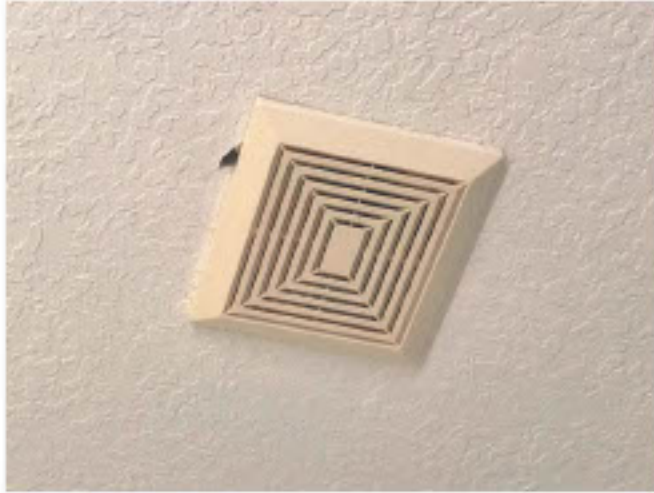
Observed small hole around exhaust fan cover. recommend repairs for full cosmetic finish

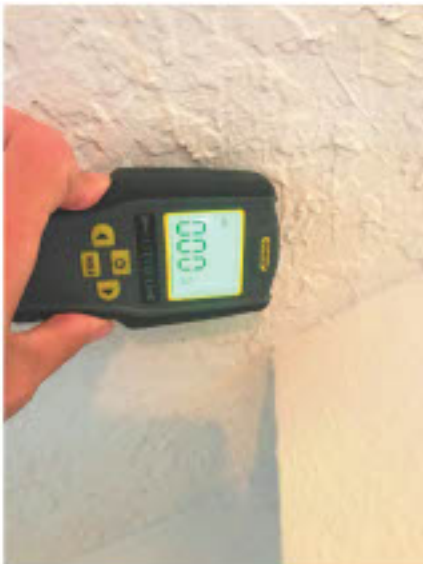
Observed moisture meter detected dry conditions within drywall indicating previous water stains

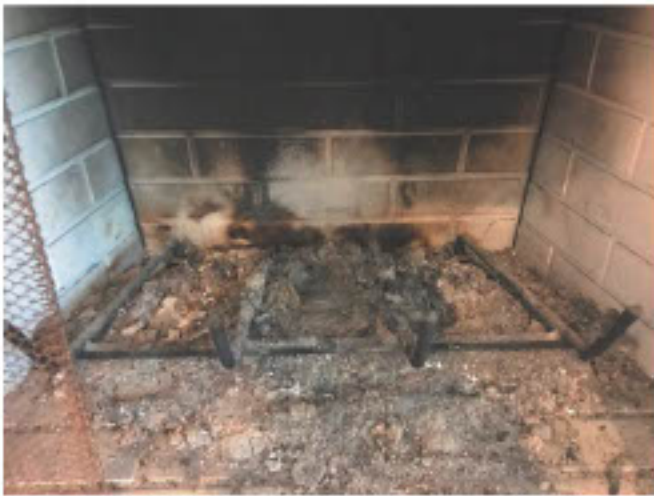
IMMEDIATE EVALUATION RECOMMENDED

Observed inner hearth and flue are dirty this is potential fire safety issue. Recommend having entire flue length professionally cleaned, all related components, inspected, tested and certified safe for use by qualified chimney contractor

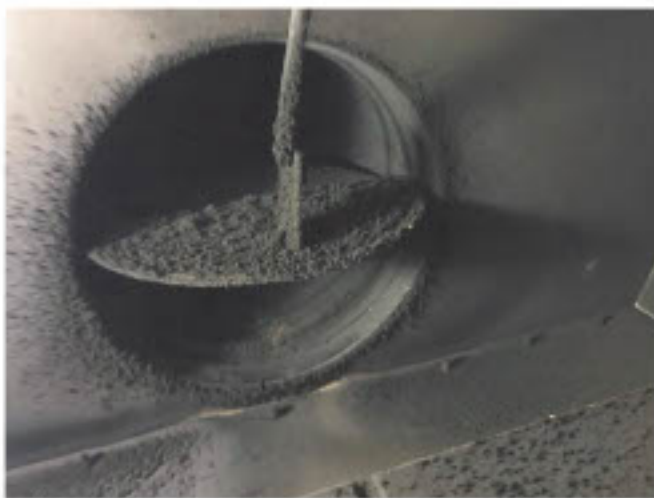
IMMEDIATE EVALUATION RECOMMENDED

Observed damper tested functional. Unit is dirty and has corrosion. Recommend prior to use having fireplace components inspected, cleaned certified safe for use by qualified chimney contractor
