SINGLE FAMILY HOME

H&H Home Inspections

Inspection Questions

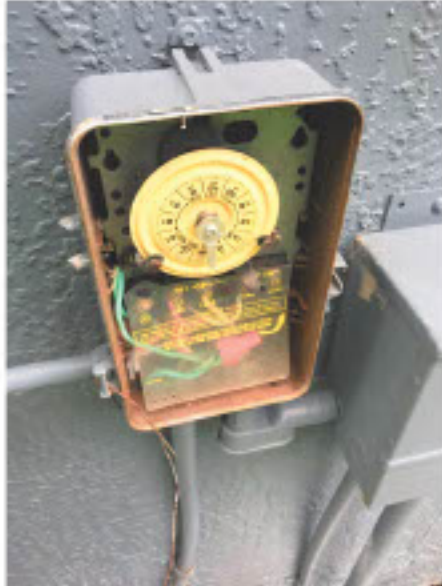
Timer

Observed timer box cover broken. Recommend replacement to prevent water penetration from damaging controls

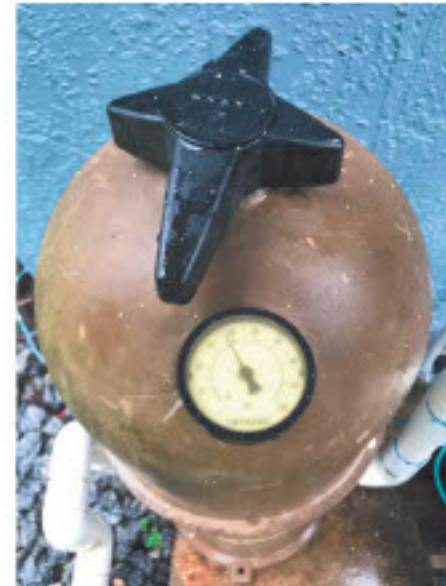
Filter/guage

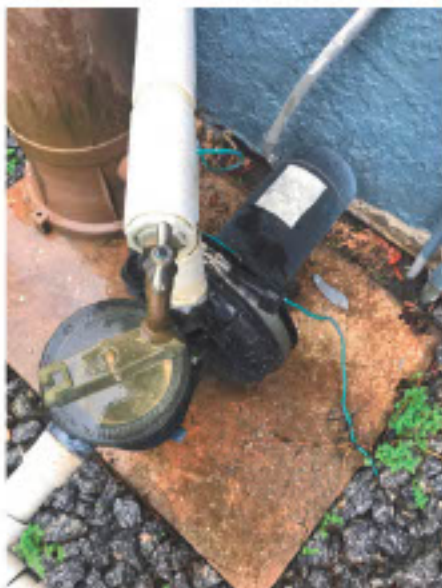
Pump

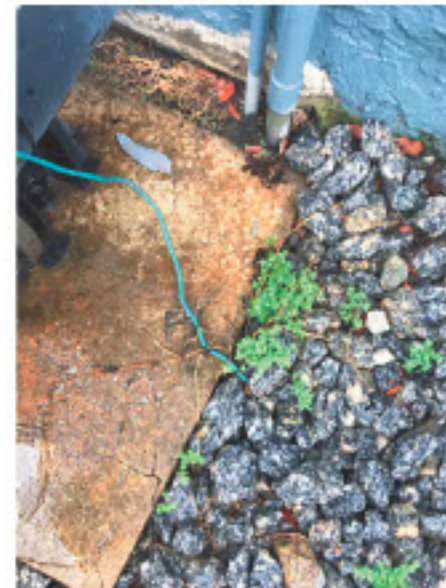
Bonding strap

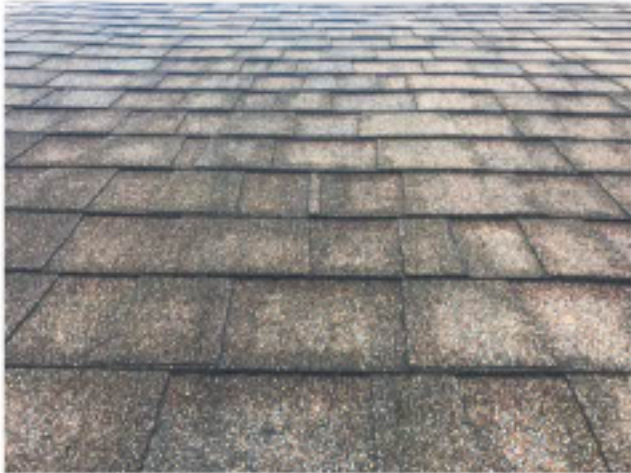
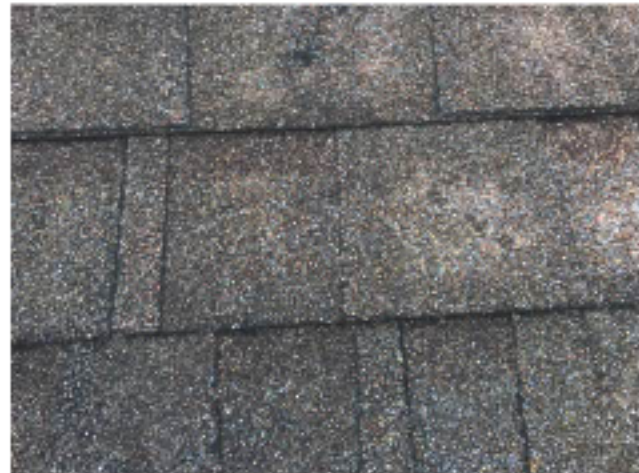
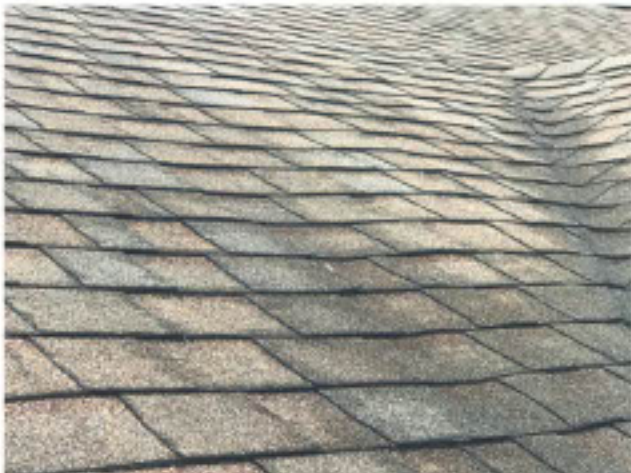
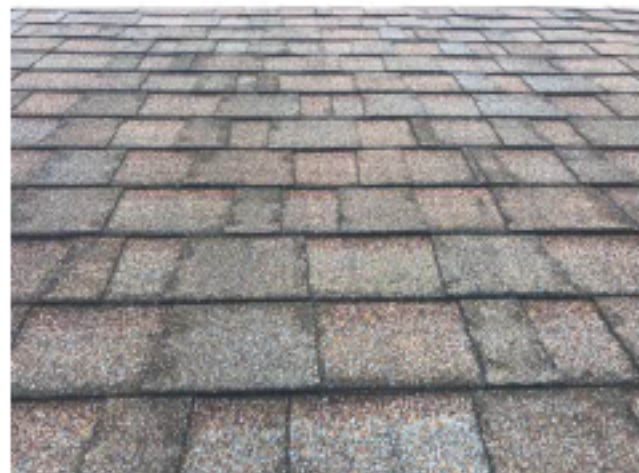
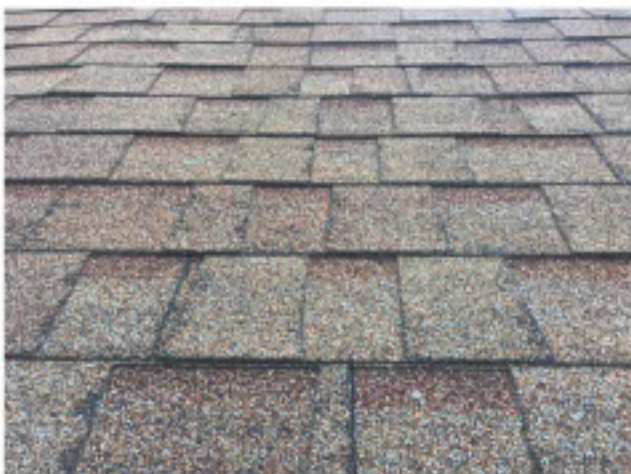
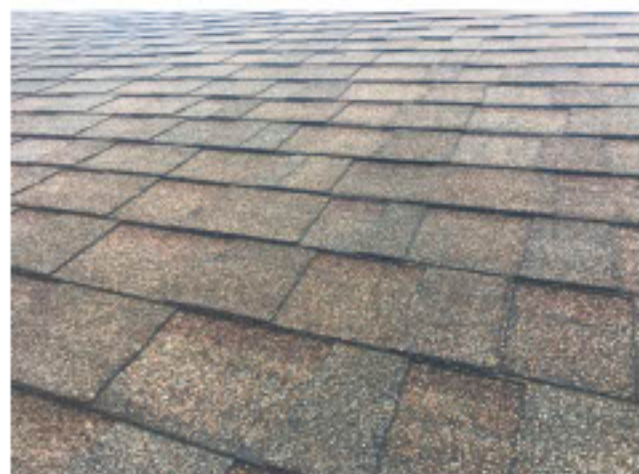
Observed shingles have granular loss and drying in various locations. No broken or missing shingles at time inspection. Understand shingles near end of functional design life and unable predict future functionality. Recommend budget for full replacement sooner than later

It is recommended that debris be removed from the roof to increase longevity, and decrease chance of moisture and pest intrusion.

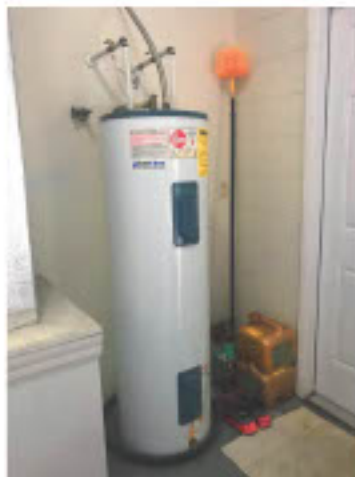
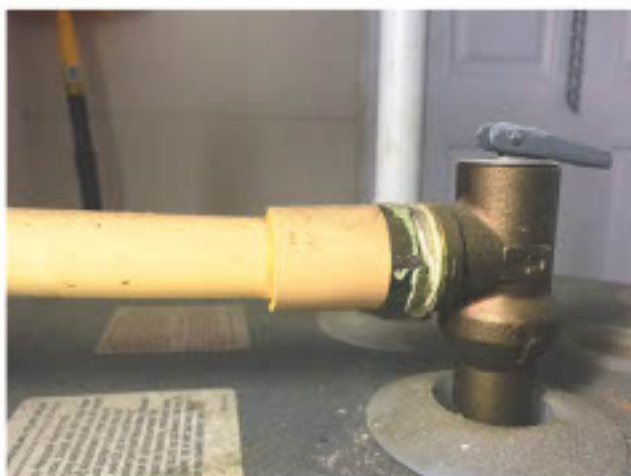
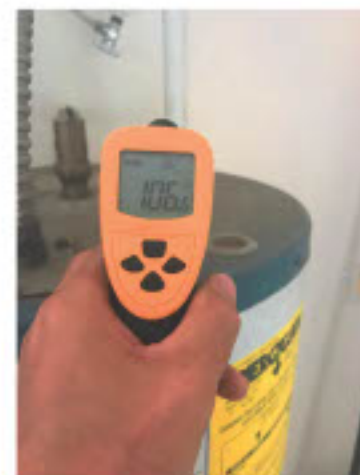
Location: Garage

Condition: Operational, but nearing the end of its useful service lifespan.

Hot water Temperature 106 F

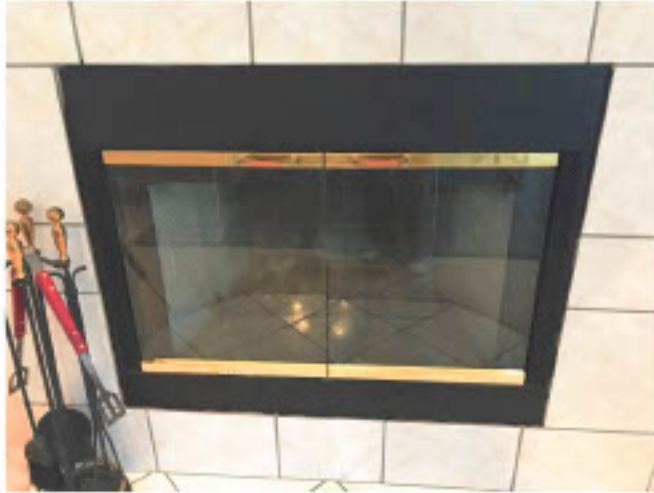
View of fireplace glass doors
